APPLICATION NOTE

Pro48 TESTER BATTERY NOTES

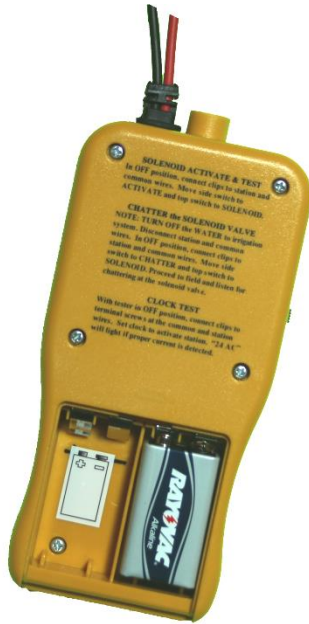
Care needs to be taken when putting 9-volt batteries in the Pro48 tester. The smaller of the two terminals (+) needs to be to the left as seen in this photo.

If the batteries are installed the wrong way they will be damaged after just a minute or two in the unit. This is because the protective circuitry in the tester kicks in and shorts the batteries out.

When you realize that the batteries are in wrong you can't just take them out and put them in right, because the batteries are probably dead. They need to be replaced by fresh alkaline 9-volt batteries.

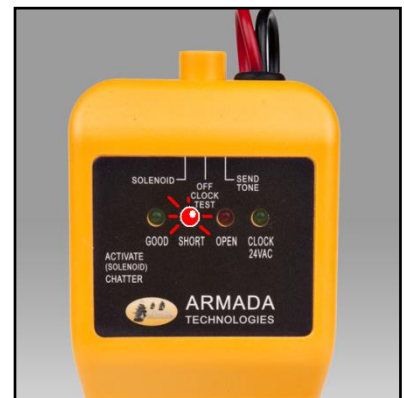
To do a quick battery check on the Pro48 short the red and black test leads together and put the unit into the 'SOLENOID' mode (toggle switch to the left) briefly. The 'SHORT' LED should come on.
